Manhole Inspection Summary

Manhole # S31YY1022MH

Insp Date: **1/18/07 9:21 AM**

Location Address: **5306 SAINT ALBANS WAY**

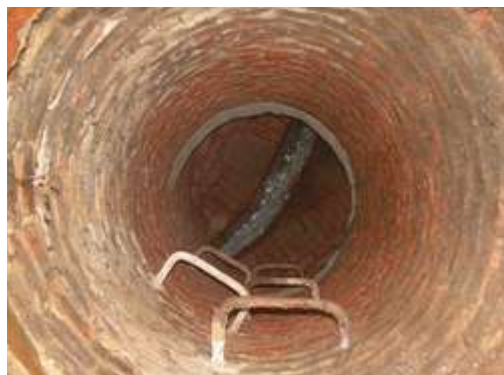
Top View

Corroded steps. Evidence of surcharge - Bench debris.

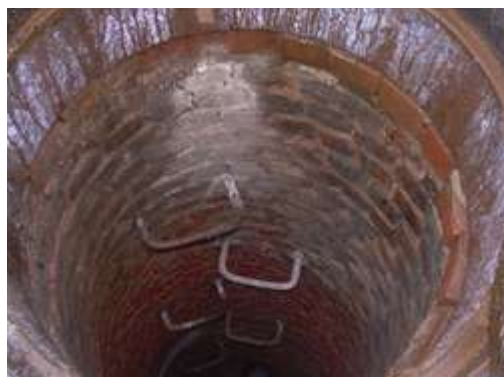
Defect

Frame leaks. Adjustment deterioration and infiltration. Corbel infiltration - other side.

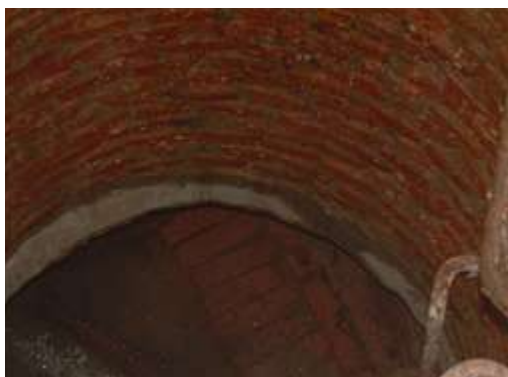
Defect

Corbel infiltration.

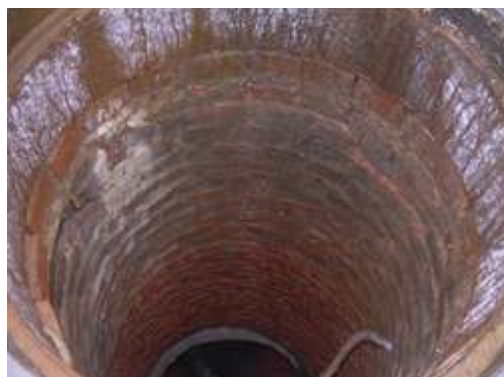
Defect

Frame leaks. Adjustment deterioration and infiltration. Corbel infiltration.

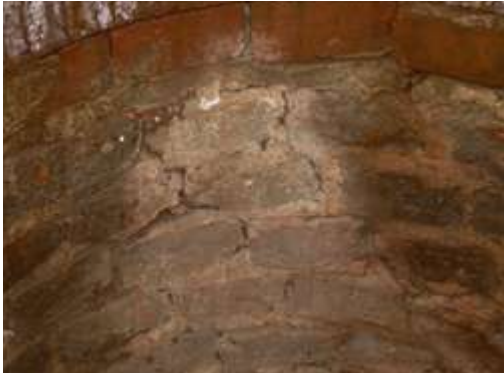
Defect

Adjustment and Corbel deterioration and infiltration.

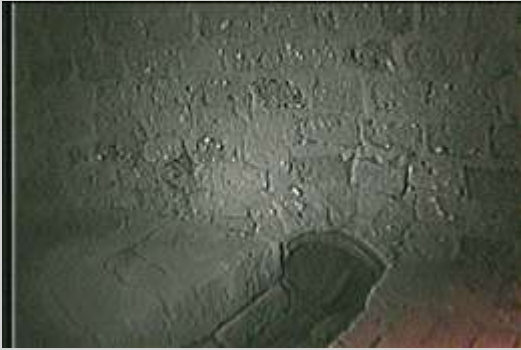
Pipe In @ 3 O'Clock

Channel deterioration.

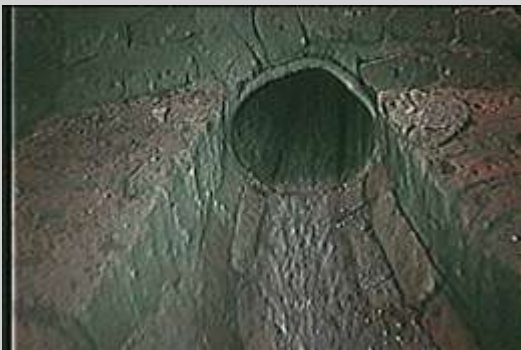
Pipe In @ 7 O'Clock

Channel deterioration.
